**REDUCTION OF FIRE HAZARD RISK IN RMG FACTORIES IN BANGLADESH
THROUGH DESIGN AND PLANNING APPROACHES.**

Md. Moniruzzaman
Student ID # 14168006

Postgraduate Programs in Disaster Management (PPDM)
BRAC University

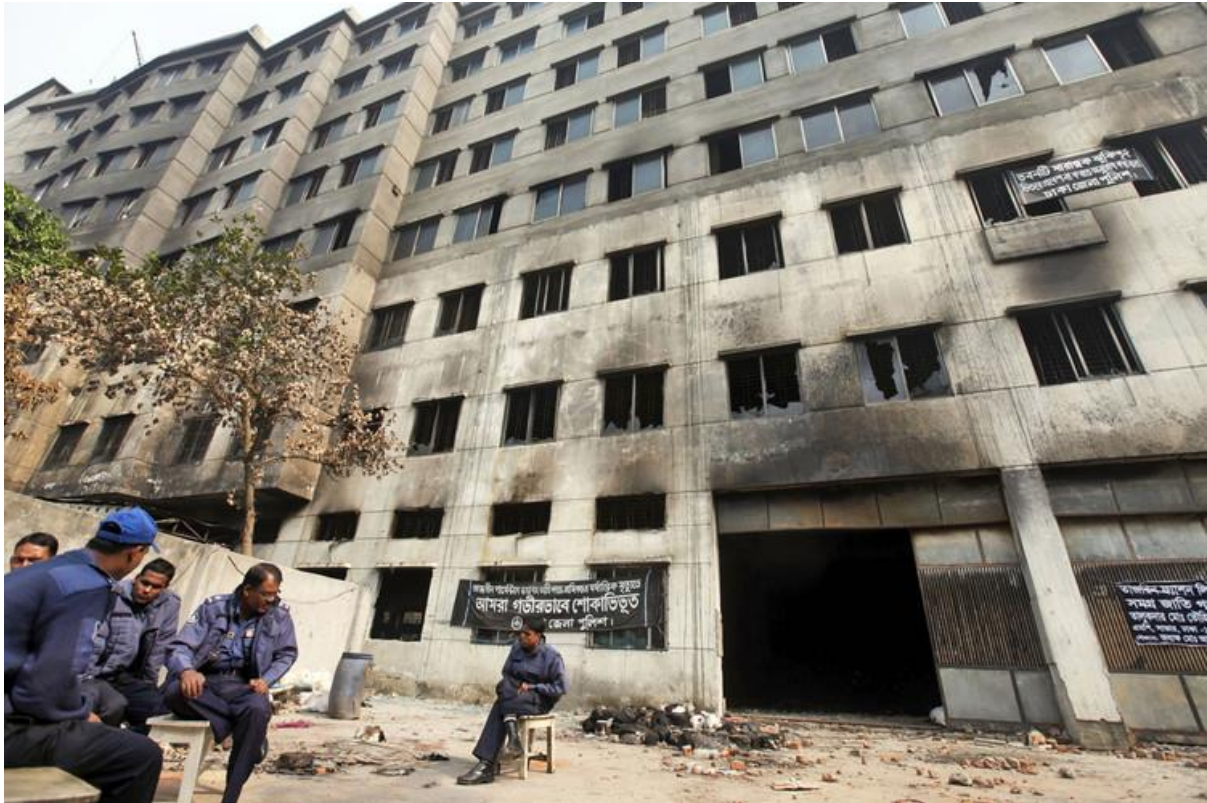
Figure 3 : Tazreen Fashion ltd. status after the fire hazard.

The fire, presumably caused by a short circuit, started on the ground floor of the nine-story factory, trapping the workers on the floors above. Because of the large amount of fabric and yarn in the factory, the fire was able to quickly spread to other floors, complicating the firefighting operations. The fire burned for more than seventeen hours before the firefighters were successful in extinguishing it.

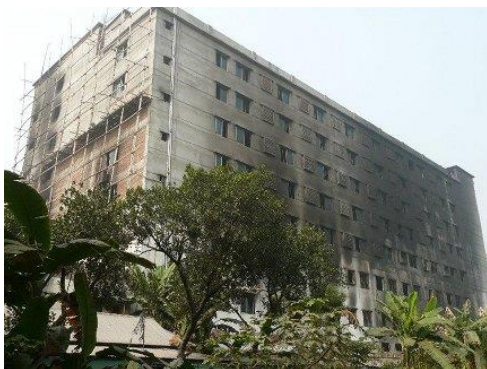
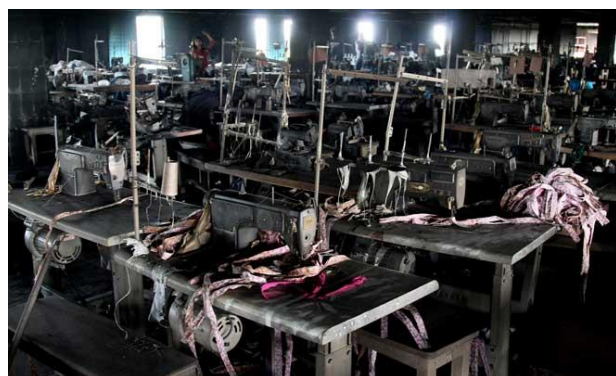
Figure 5: Tazreen Fashion ltd. After the fire hazard.

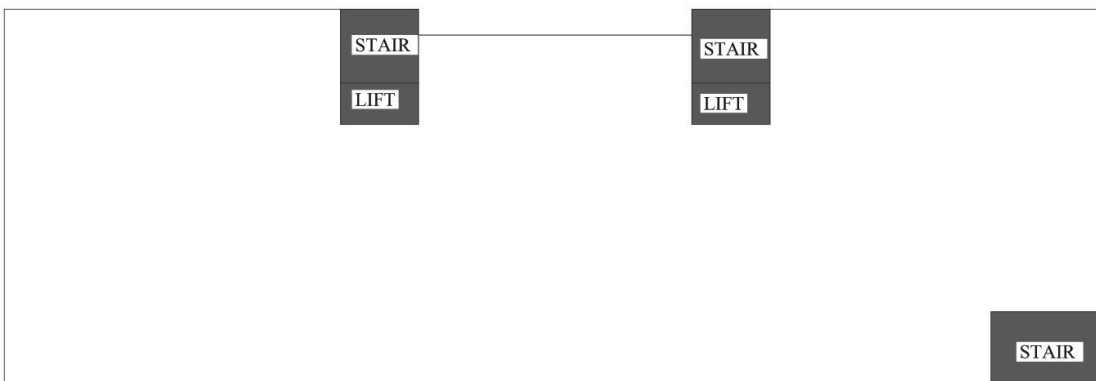
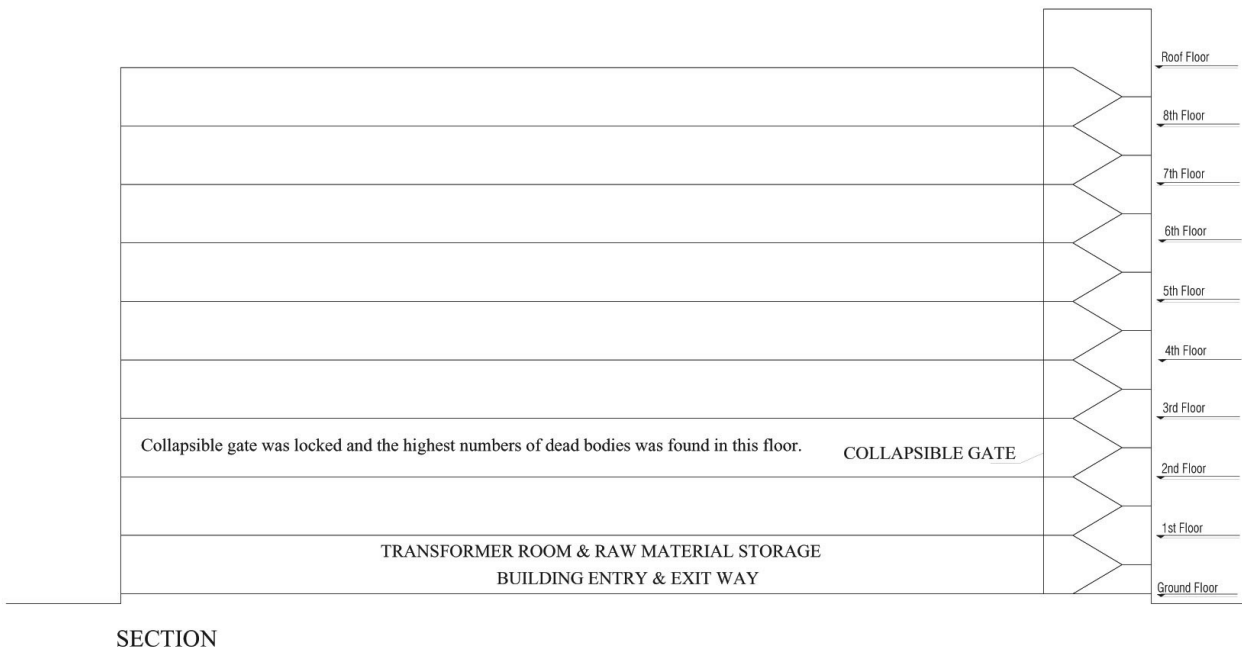
Figure 9 & 10: Plan and Section of the building showing vertical circulation layout.

The factory building not designed as per Bangladesh National Building Code of Building Construction Act. Authority has approved for 3 storied but the building was constructed as 9 storied without having any fire exit.

The building only one entry & exit from the ground floor where the high voltage electrical transformer was located and also the access route was obstructed with raw materials. All three stairs of the building had open newel where from the smock can spread through and also had scope for falling down on way of escape.

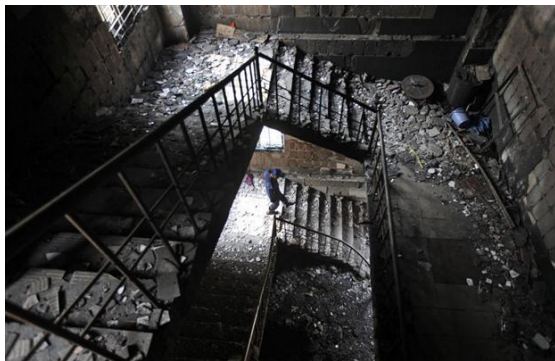
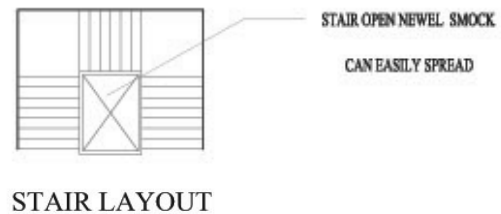
Figure 11 : Tazreen factory stair.

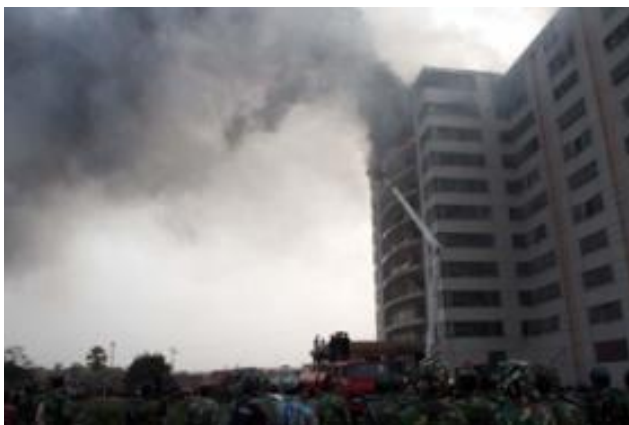
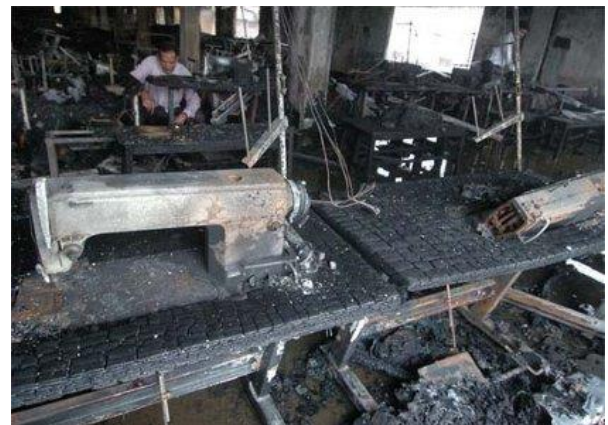
Figure 13 & 14 : View of Garib & Garib Factory during fire hazard and its after effect.

The fire broke out around 9:00 pm on the first floor of Garib and Garib's six-story factory building, apparently due to an electrical short circuit. At the time, most of the factory's workers fortunately had left for the day, but several dozen workers were still sewing garments on its fifth and sixth floors. With the factory's electrical system disabled, the facility – which lacked emergency lighting, a basic safety provision in such circumstances – was rendered completely dark. Due to poor ventilation as a result of the factory's windows being sealed with heavy metal shutters, smoke and fumes rapidly filled the building.

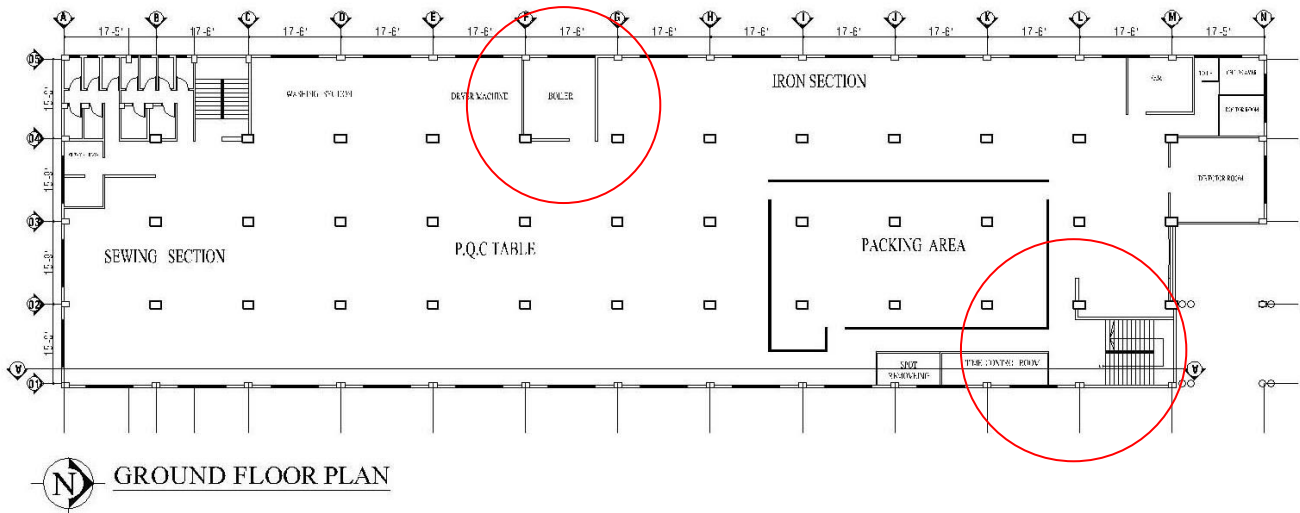
Figure 19 : Layout Plan of the building showing error in arrangement.

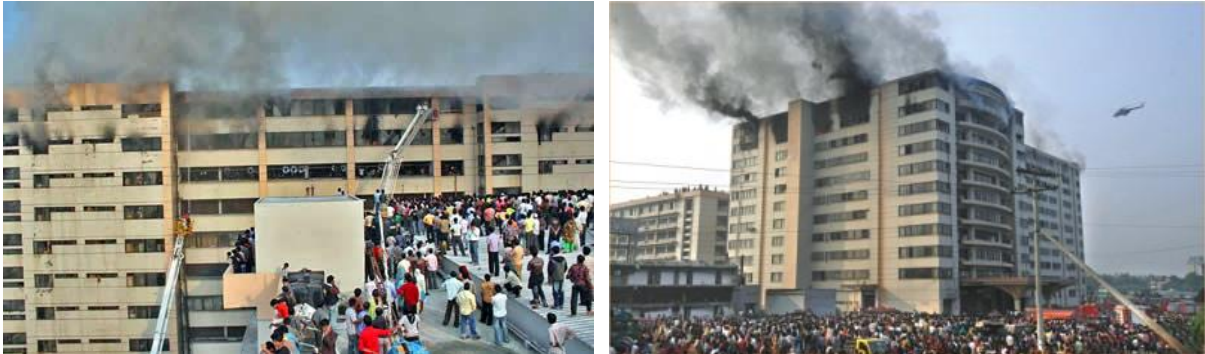
Figure 22: Fire hazard in Ha-Meem Factory.

Around noon on December 14, 2010, a fire emerged at the Ha-Meem garment factory, resulting in 28 fatalities and more than 150 injuries. The time when the fire emerged coincided with the lunch break. Consequently, although more than 5,000 employees work at the facility, many of them had gone home or otherwise left the building. The fire was caused by a short circuit in the electric wiring on the 9th floor, where the finished product was stored for shipment. About 450 employees were having lunch on the 10th (highest) floor when the fire broke out, while there were virtually no people on the 9th floor. The fire spread through openings in the outer wall and the freight elevator shaft. On the 10th floor (where the fire
