EVALUATING VULNERABILITY AND RESILIENCE IN THE FACE OF EARTHQUAKE AND FIRE RISKS

A thesis submitted to the Department of Architecture in partial fulfillment of the requirements for the degree of Master in Disaster Management

> Postgraduate Program in Disaster Management (PPDM), Department of Architecture BRAC University April 2023

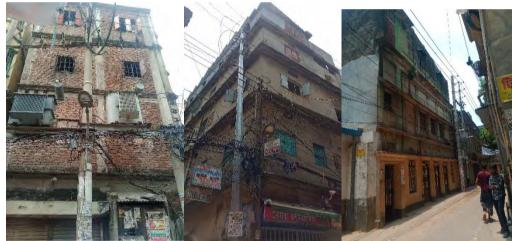
Figure 30: Sample 09

For Sample 9 in Figure 30, the whole building is used for commercial purposes and workers live here as well. For sample 11 in figure 31, 4 families live there and there is a shop on the ground floor. From figure 32 sample 13, the warehouse is on the ground floor, and on the upper floors, 6 families live there. Here we can see that most of the buildings are mixed-use buildings. It seems that 50% of the structures are two stories tall, while 30% are four stories. The remaining ones are structures of 3 and 5 stories. However, since there is extremely limited space for roads in buildings with four and five stories, they may block them during an earthquake and hinder emergency escape.

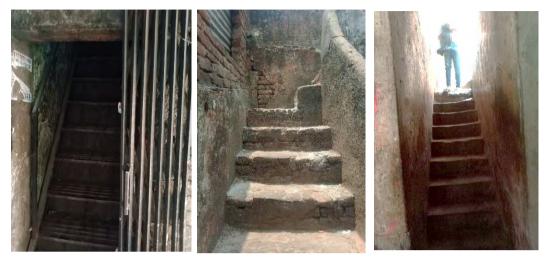
Figure 35 Sample 6

Figures 35-37 and 40-42 show some stairs that looked vulnerable in ward 29. Some of them have very weak structures and some are not having enough width. In Figure 42, the stair of sample 4 is externally added which was not a part of the existing plan. These are some stair issues that are making the structure vulnerable.
