Infrared Thermography Based Performance Analysis of Photovoltaic Modules

A thesis submitted to the Department of Electrical and Electronic Engineering in partial
fulfillment of the requirements for the degree of
Bachelor of Science in Electrical and Electronic Engineering

Department of Electrical and Electronic Engineering
BRAC University
April 2019

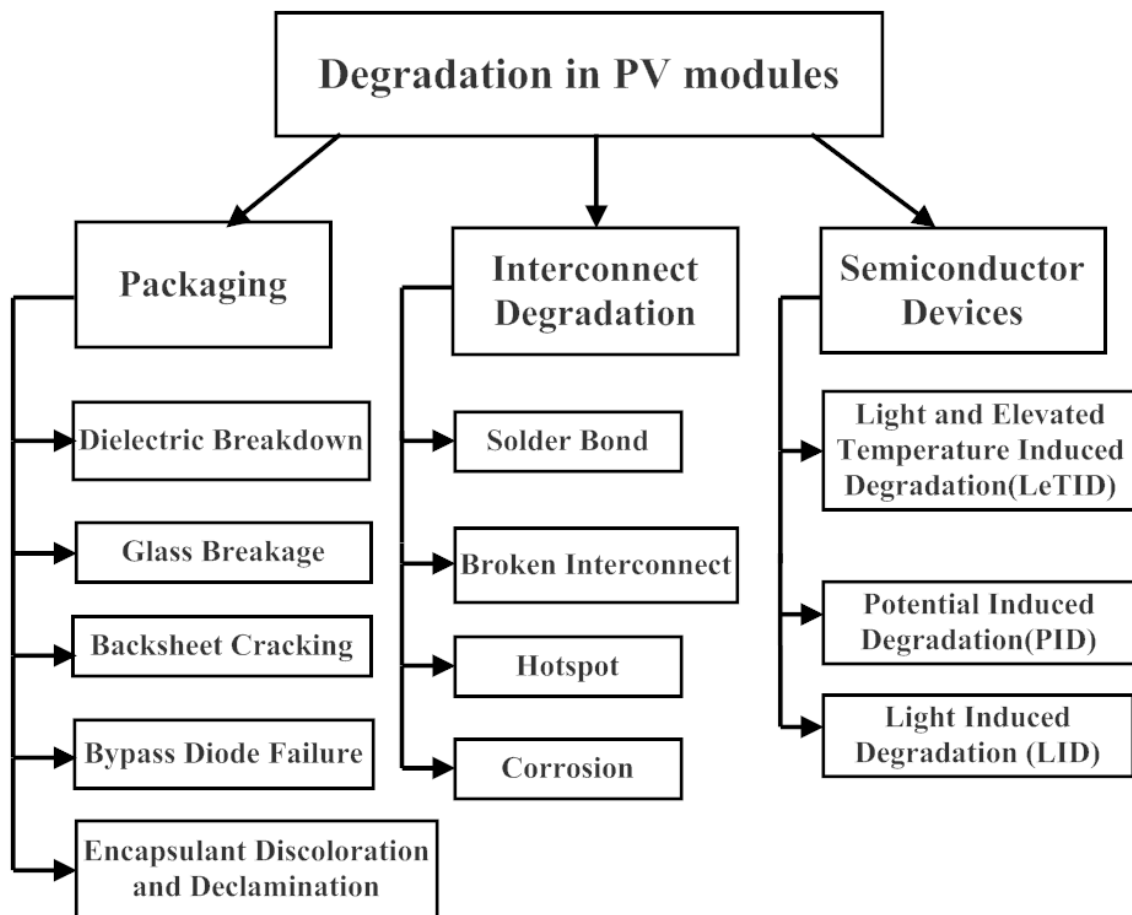
Fig. 2.4: Different possible modes for the degradation of photovoltaic modules from packaging, interconnections and device levels [19]

To assess their performance over time and therefore their lifetimes, it is important to identify modes of degradation failure for PV modules. The identification of degradation failure modes on PV modules is important to evaluate their performance along time and so their lifetime. The functioning capability within the suitability standards describes the lifetime of the PV module. Large influx of PV systems worldwide requires a growing demand for laboratories capable of analyzing early degradation and concealed deficiencies in PV modules. The main causing factors for degradation are temperature, humidity, irradiation and mechanical shock. Dismantling causes can be divided widely into three levels: packaging, interconnection and equipment. Typically, product failures are classified into three categories from a lifetime perspective: infant failures, midlife failures, and wear - out failures. Over time, module power

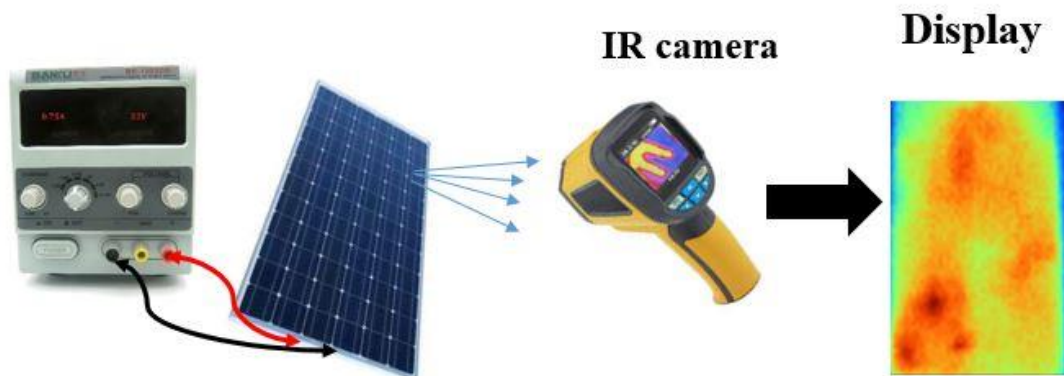
Fig. 2.5: Process of having infrared image of PV modules

radiation is analyzed to generate thermograms that create heat distribution map and superpose it on the original image along with determining the surface temperature all across any inspected

body in this study it mapped the heat distribution on the PV modules both on panel side and the junction box view on panel side and the junction box view.

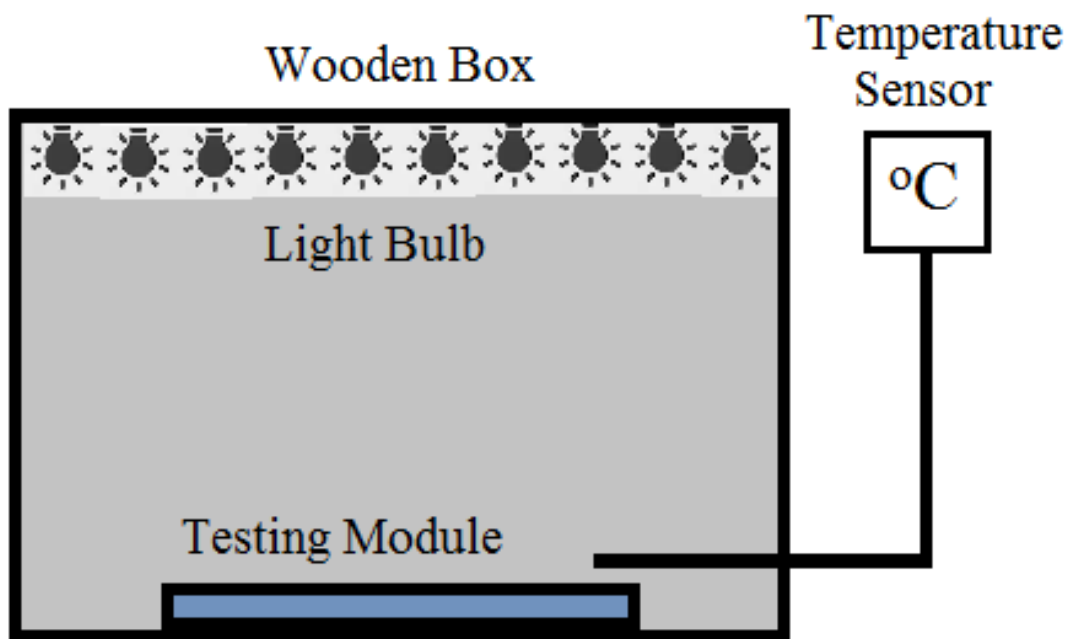
Fig 3.2: Schematic Diagram of Experimental Set Up for The IV Measurement of PV Modules.

measurement data of the modules. A 100 ohm rheostat as shown in Fig. 3 is used as the load for the modules. By varying the load resistance, the voltage and current data of testing module are recorded under different temperature and illumination conditions. To get the open circuit voltage, switch S-1 is kept open and to get the short circuit current, both S-1 and S-2 switches are kept closed. For measurements under standard temperature condition, a temperature of 25°C is maintained with the help of room air conditioner. For measurement at higher temperatures, temperature is first allowed to rise to the desired level in the closed box under illumination, and then a fan is used to control the panel surface temperature manually. First, $I-V$ measurement data are recorded for two different illumination levels set with four and eight bulbs while maintaining a constant panel temperature. Then $I-V$ data were recorded at a fixed illumination while varying the temperature over the range from 25 °C.

An experimental platform was set up as shown in Fig.3.2 Center to the setup is a wooden box, shown as the shadowed region in the figure, which is used to provide the non-illuminated environment for the sample module. An external DC power supply (30V/3A) was used to provide forward voltage and current to the PV modules. Digital temperature sensor was used to measure the ambient temperature with the help of a microcontroller. Distance between the camera and the PV module was set at one (1) meter. Several images have been taken for each PV sample.

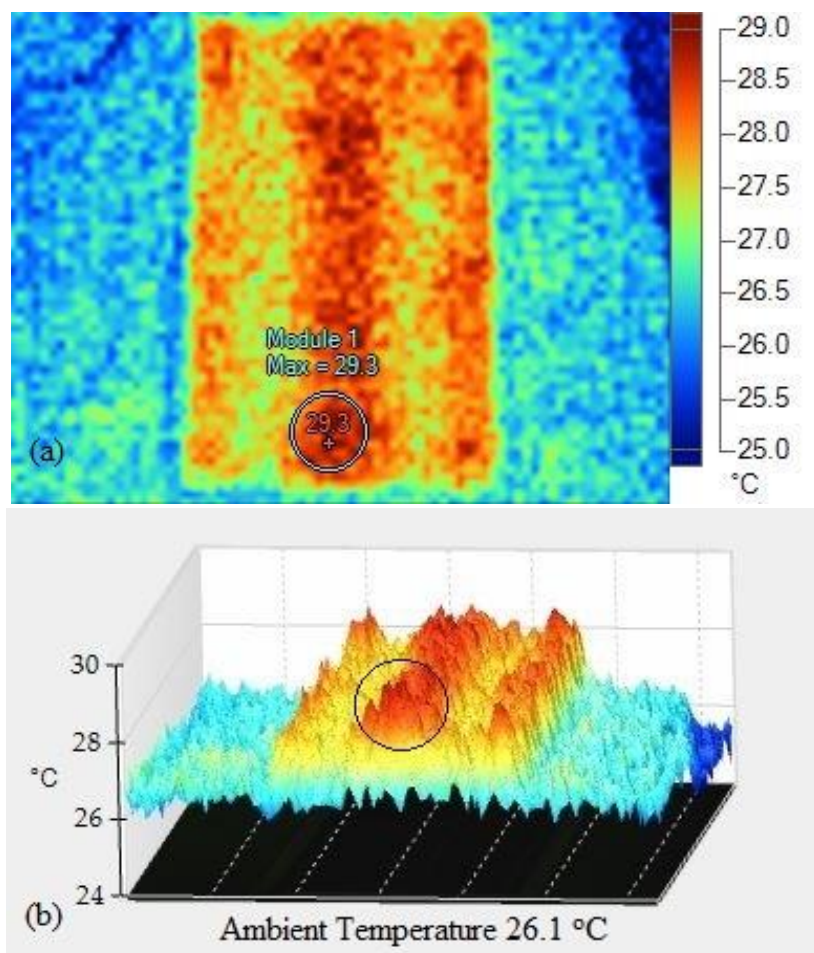
Fig. 4.3: (a) Thermal image of module 1 (b) 3D diagram of surface temperature distribution.

Figure 4.3 shows (a) the IR thermal image of module 1 and (b) the 3D view of temperature distribution on the module surface. It shows that cell interconnector of module 1 shows hotspot. Beside the interconnectors, temperature distribution is moderate. Solar cells within the interconnecting regions shows high temperature. Circle indicates the hottest region which is the probable hotspot area. The ambient temperature during the test was 26.1°C and the highest Temperature in hotspot region was 29.3°C. Temperature difference is 3.2°C for module 1 for the marked region.

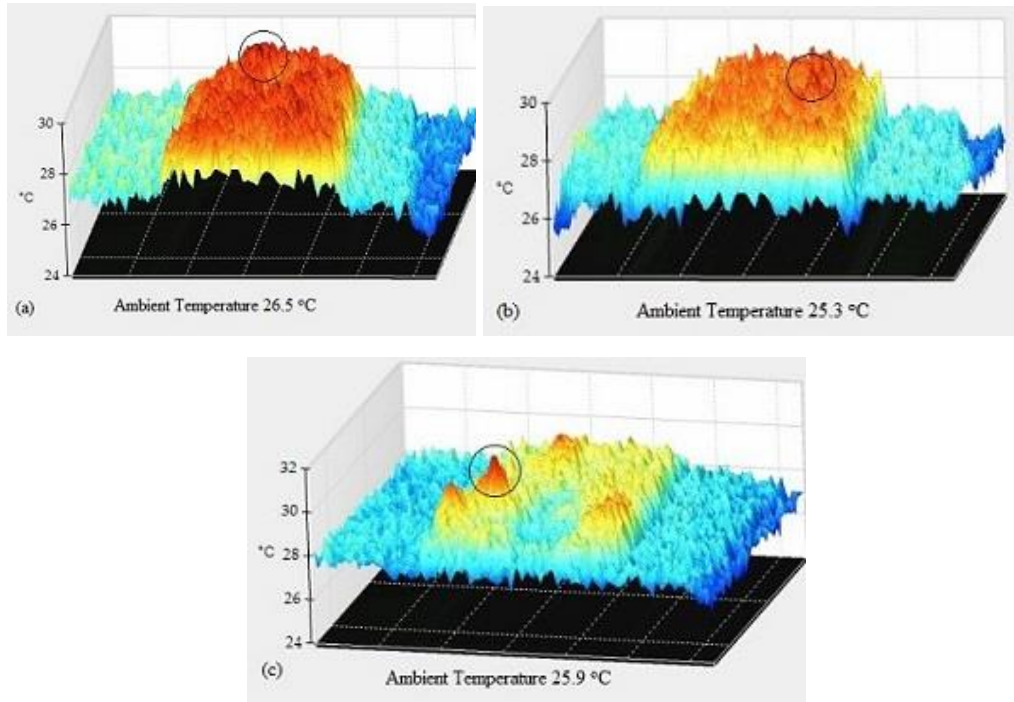
Fig. 4.4: 3D diagram of surface temperature distribution of (a) module 4 (b) module 3, (c) module 2

Figure 4.4 shows the 3D temperature distribution image of (a) module 4, (b) module 3 and (c) module 2. The module 4 demonstrates a slightly lower performance (-5.16%) than the reference module 1. 3D image shows that cells and interconnectors create hotspot. From visual inspection data some possible area of hotspot region is found which are similar to this IR image. The ambient temperature was 26.5°C and the hotspot region temperature difference is 3.7°C marked by the circle. Module 3 shows 6.64% less power output than the reference module. 3D image also shows hotspot region in the cell interconnectors as like module 4. Ambient temperature was 25.3°C and temperature difference is 4.5°C on the marked region. However, it can be seen from the Fig. 4.4(b), IR radiation is more intense on the right side for the module 4, indicating more heavily resistive solder joints are likely to be present between the cell interconnectors. The output of module 2 is lower than the reference module by 10.91%. The Fig. 4.4(c) shows several hotspots in this module. Probable resistive connectors and visually observed discolored cell gridlines are the main cause of the hotspots. Also, this module shows highest ΔT value over 5°C in the marked hotspot area which represents serious defects occurred in this module 2.

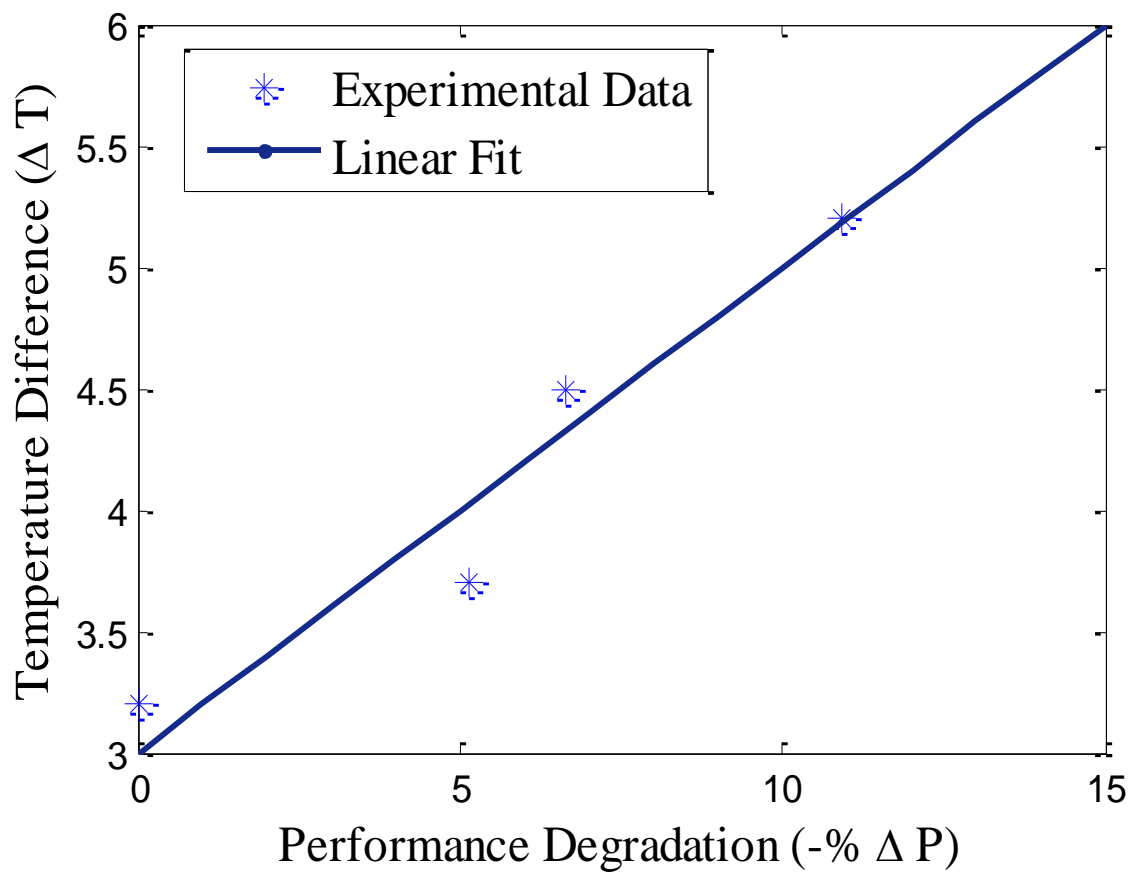
Fig. 4.5: Temperature difference between hotspot and the ambient temperature with respect to performance degradation

It is observed that as the performance of the PV modules gets worse, the temperature of the hotspot region increases. There seems to be a correlation between the difference in

temperature in the hotspot region and the performance of PV modules. Figure 4.5 shows that the difference in temperature between ambient and hotspot temperature is perhaps linearly increased with performance degradation of PV modules. To understand the relation linear curve is fitted. It shows that when the percentage of performance degraded, temperature difference is increased in marked hotspot region of PV modules. The more the degradation, the more the temperature differences. Also, the temperature maintains a linear rise up. The panels were provided with 1A and 23 volts for a different time frame.

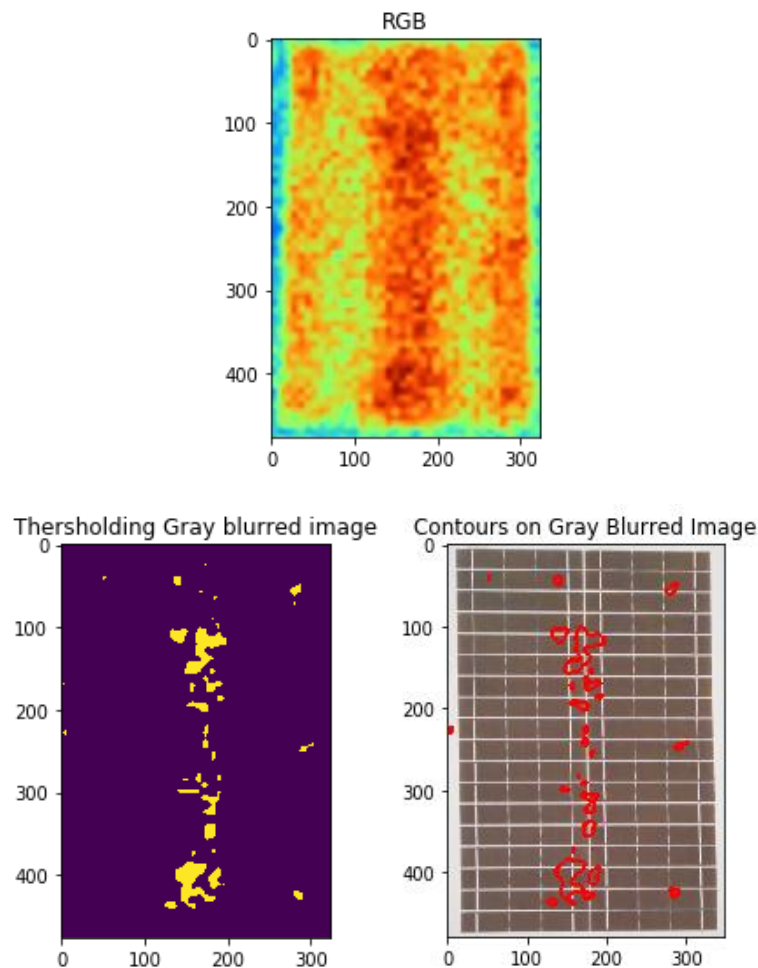
Fig.4.9: RGB, Thresholding Gray Blurred Contours and Gray blurred images of Poly-Silicon 1 PV module

The infrared image of this panel reveals numerous hotspots along the middle but it is perceivable that not all of them are hotspots with the highest temperature. Thresholding was applied and contours detected which shows prominent hotspots not only in the middle but also on the left face of the panel.

Plotting the contours on the real PV panel image points to a possible defect in the center gridline and visual inspection showed misalignment in the gridlines. Furthermore, the area calculation showed that the largest hotspot was 0.7244582043343654 % and all hotspot totaling to a 2.5465211015153986 % defect on the panel contributing to a power loss of the module.

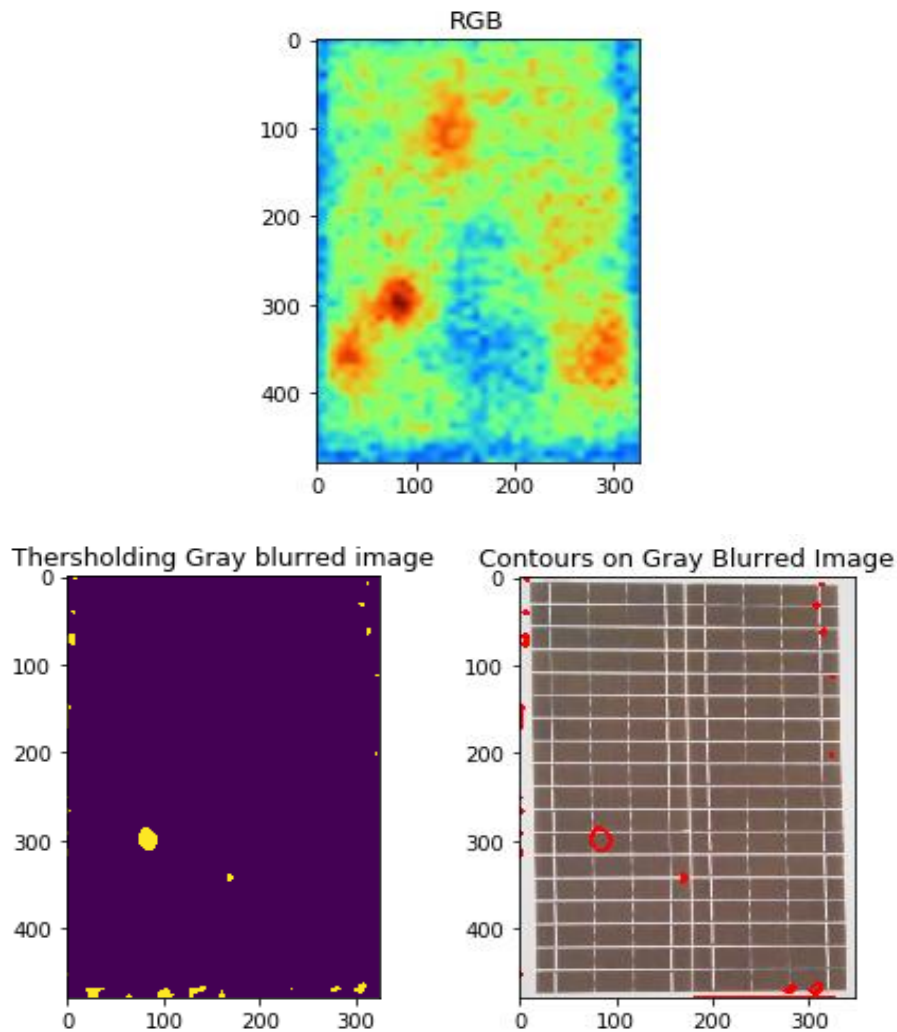
Fig.4.11: RGB, Thresholding Gray Blurred and Contours on Gray blurred images of Poly-Silicon 3 PV module

The P3 PV module shows 4 probable hotspots. But only one of them has a temperature difference. So, applying thresholding shows exactly that. Contours were detected and shows a defect of 0.4905053105889926 %.

When visualized it shows the problem lies in a single cell of the module which contributes to the power loss of this PV module.

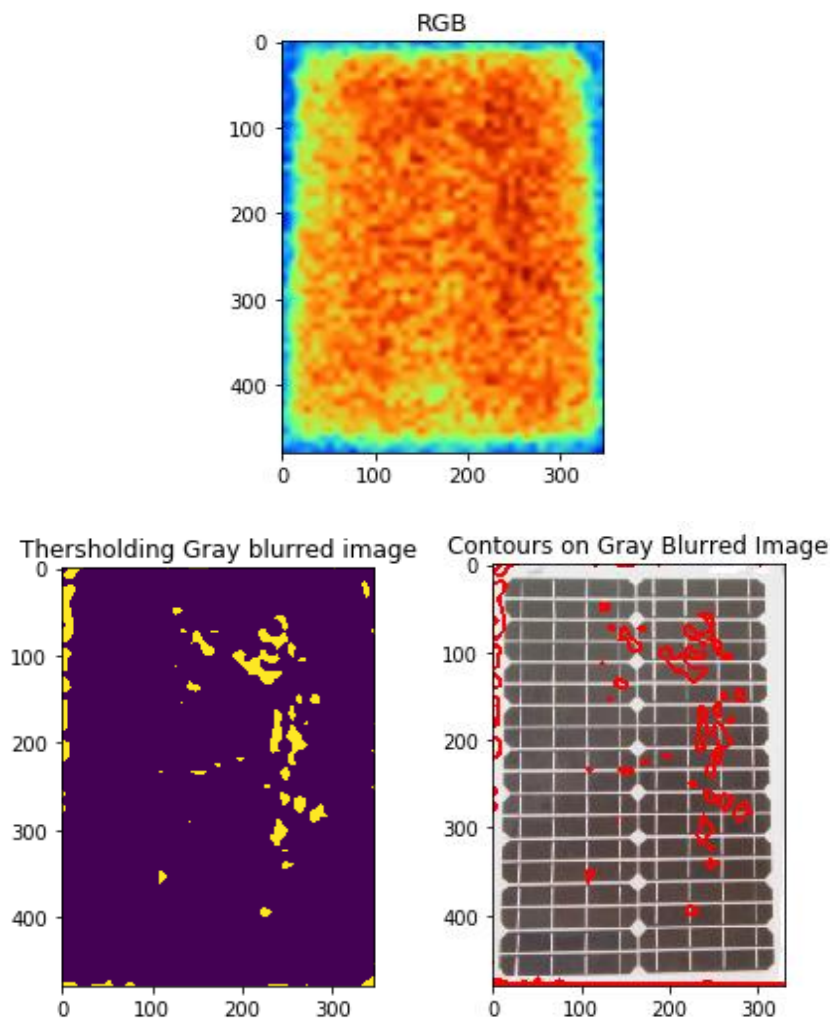
Fig.4.11: RGB, Thersholding Gray Blurred and Contours on Gray blurred images of Mono-Silicon 1 PV module

The infrared image of this PV Panel shows an even distribution of hotspots only some of them reveals a hotspot with the highest temperature. Applying thresholding reveals major hotspots on the right face of the panel. But a lot of noise was generated due to camera encoding conflicting with blue and red values which can be removed.

Detecting contours shows the largest hotspot of 0.5221029652537748 % while totaling to a defect area of 3.5992359468801163 %
