Exploring Hazard Risks and People's Adjustment: A Study in the Downstream of the Padma Multipurpose Bridge Project

A thesis submitted to the Department of Architecture in partial fulfillment of the requirements for the degree of Master in Disaster Management

Postgraduate Programs in Disaster Management (PPDM)
Department of Architecture
Brac University
April 2022

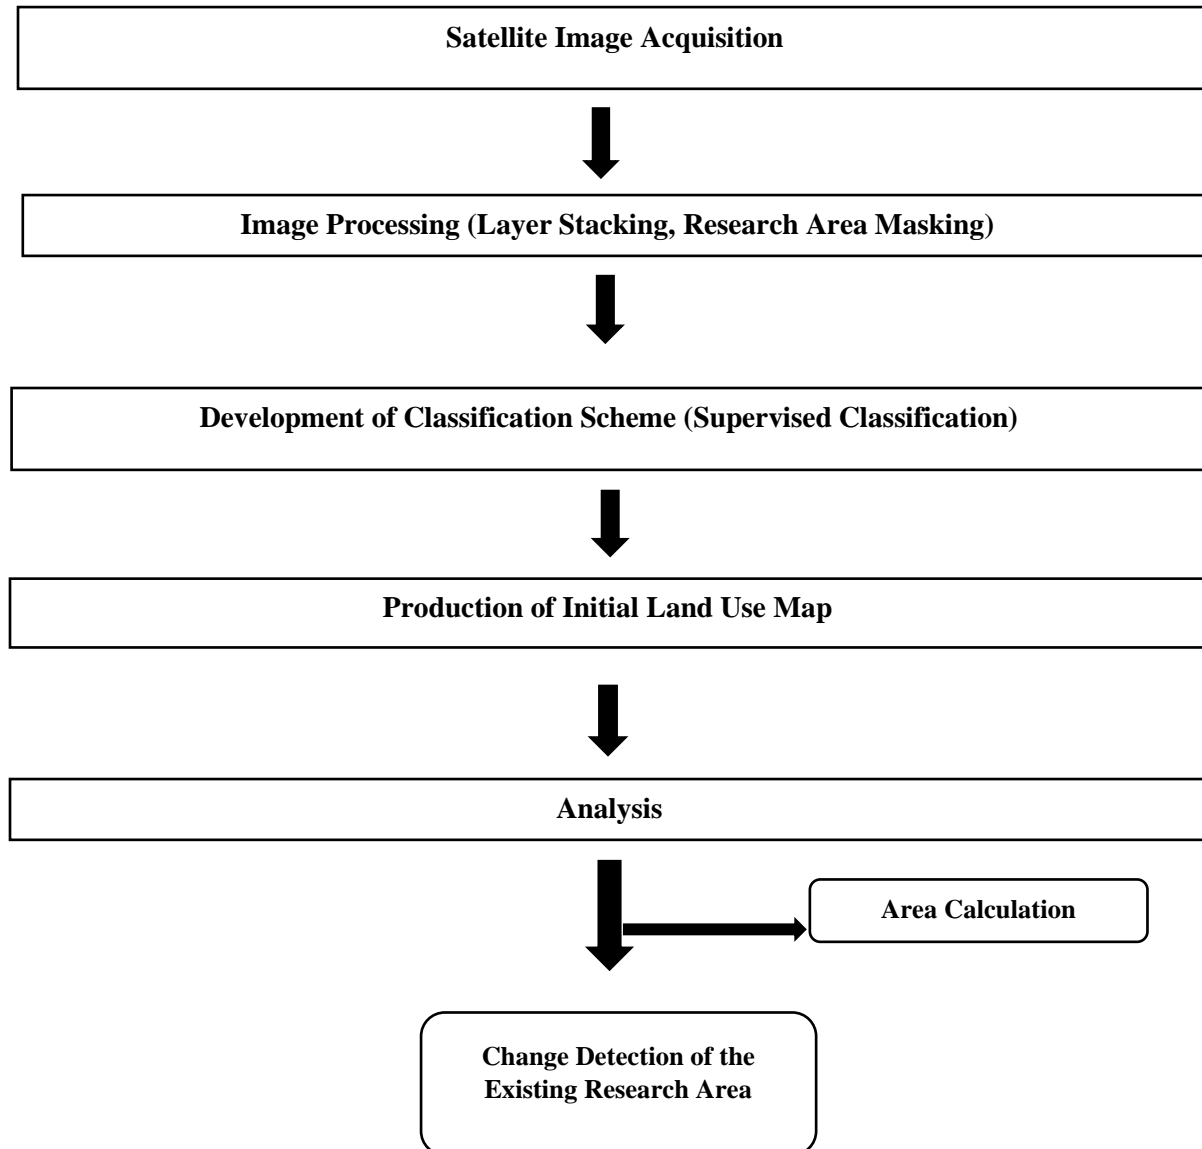
Figure 3.3: Flow chart of the methodology

In the flowchart, it has been described that at first Satellite Image Acquisition was done to collect the right images. After that using Layer Stacking, Research Area Masking images were processed. Then after developing classification scheme, initial landuse map was produced. At last it was ready for analysis.

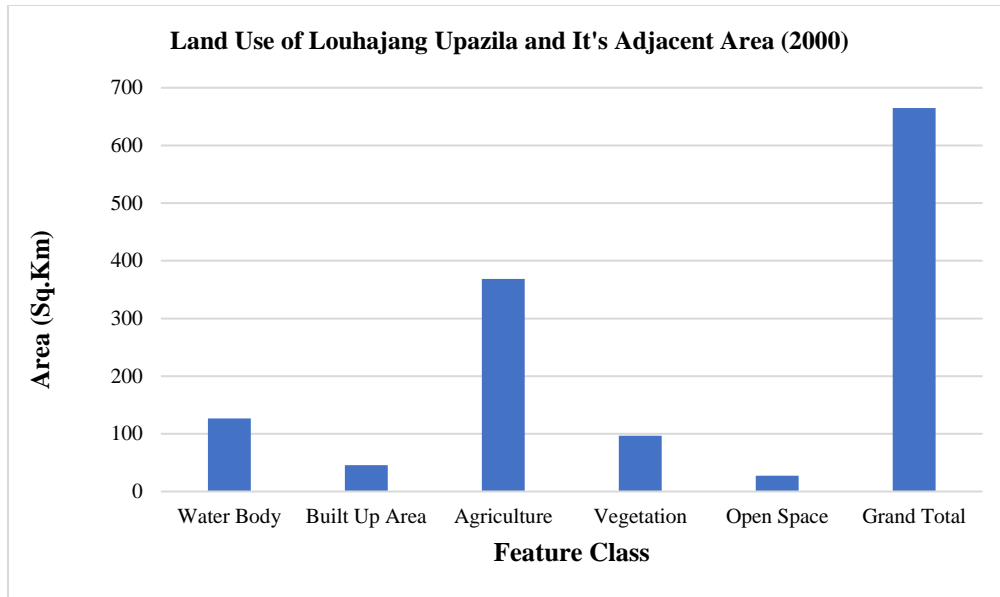
Figure 4.2: Land use change of the intervention area (2000)

Therefore, (Figure 4.2) , most of the lands (370 sq.Km) were being used for agricultural purposes at 2000. It has been evident that at that time the rate of erosion in the Uria village was less and that is why people could rely on agriculture for their livelihoods. 120 sq km of areas were water bodies at 2000. From the overall land use pattern, very few spaces were regarded as open spaces.

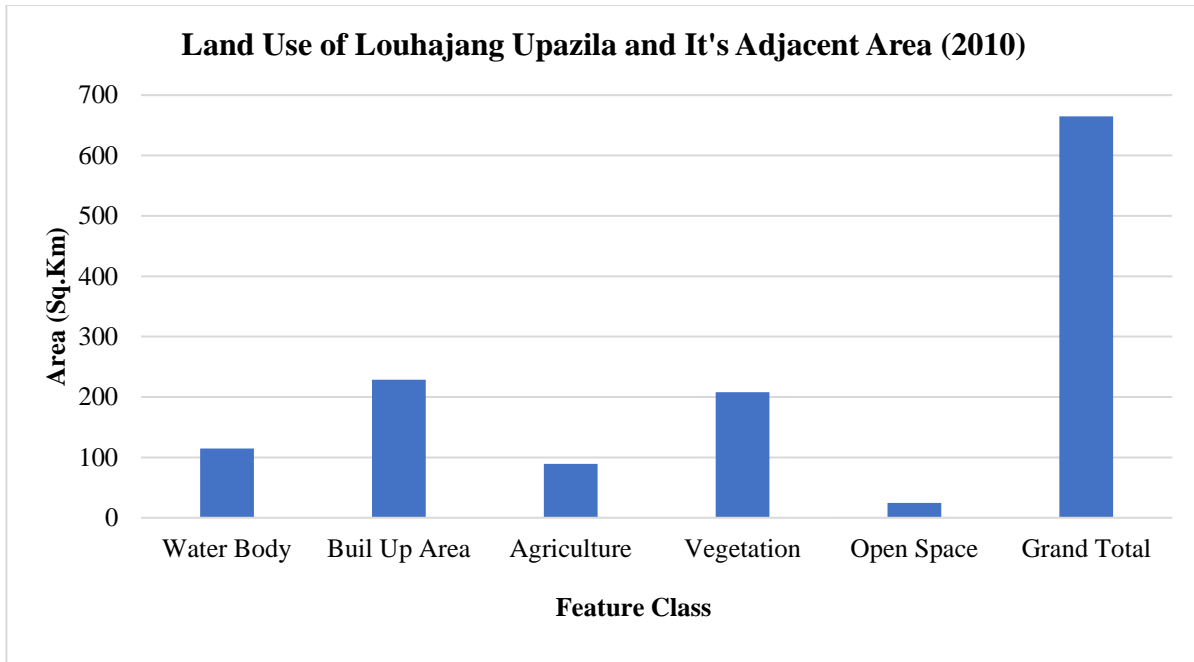
Figure 4.4: Land use change of the intervention area (2010)

From figure 4.4, it has been found that , in 2010 lands occupied for built up areas and vegetation are similar (213 sq. Km and 202 sq. Km respectively) . The portion for water bodies remained similar with the 2000 land use patterns. But the land use for the agriculture plummeted to 90 Sq.Km within 10 years of time frame.

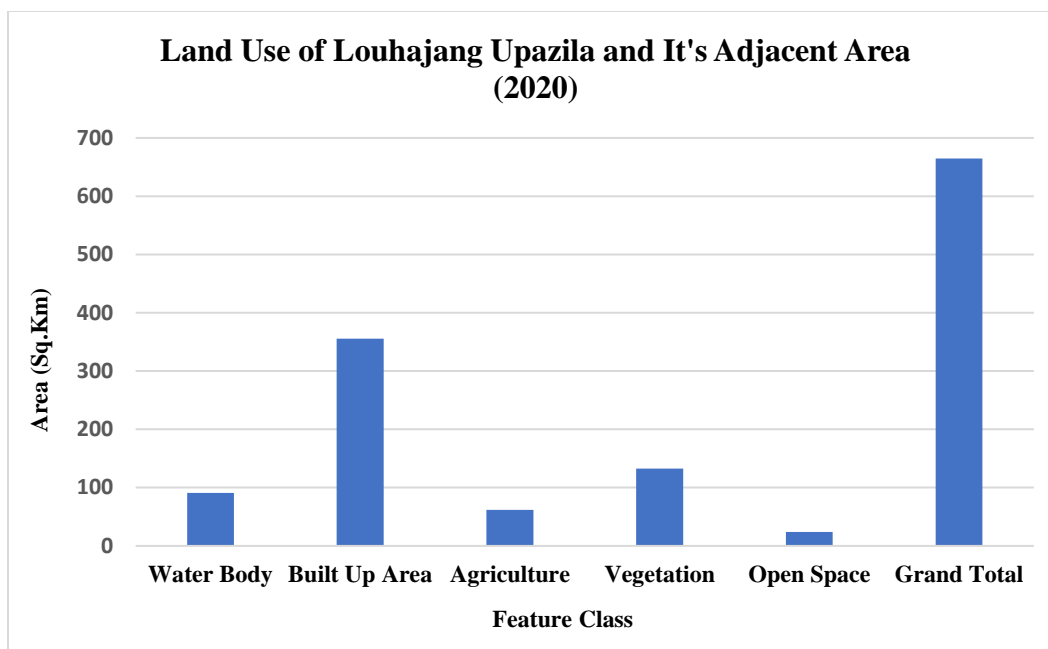
Figure 4.6: Land use change of the intervention area (2020)

In 2020, the built up area has been occupied 355 Sq Km of land which is significantly larger than any other type of landuse. Due to the construction of the Padma Multipurpose Bridge Project which began in 2004, the erosion rate had been increased in the downstream of the river and so many people have relocated and build up area has been increased in Louhajang.

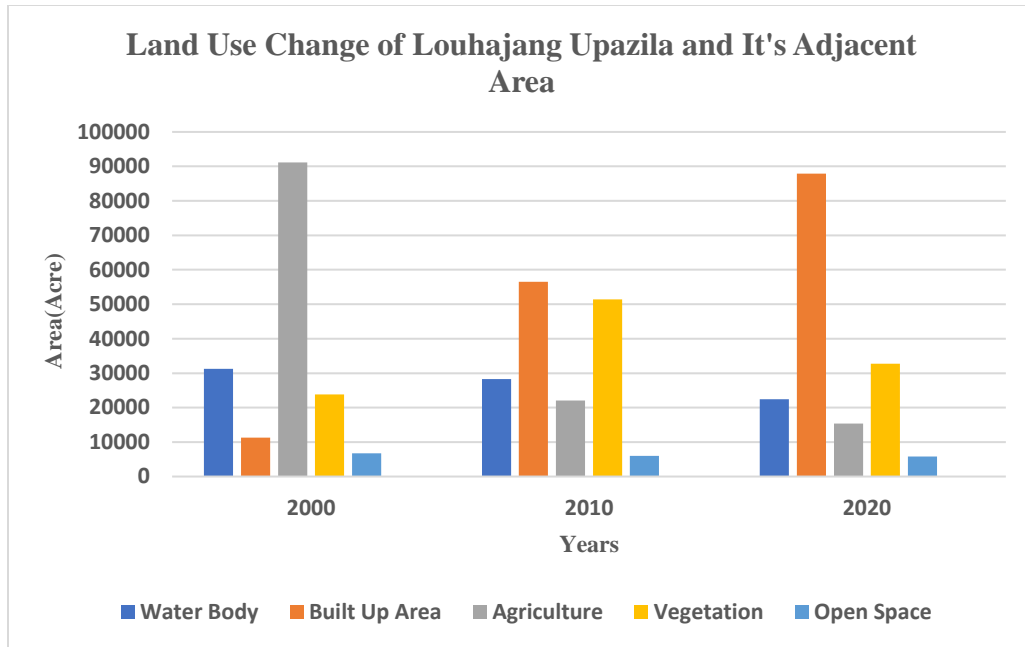
Figure 4.7: Existing land use comparison of the intervention area.

In 2000 agricultural lands were predominant whereas in 2010, both build up areas and vegetation areas were close to each other. In the current stage (2020), the portion of build up area has become largest.

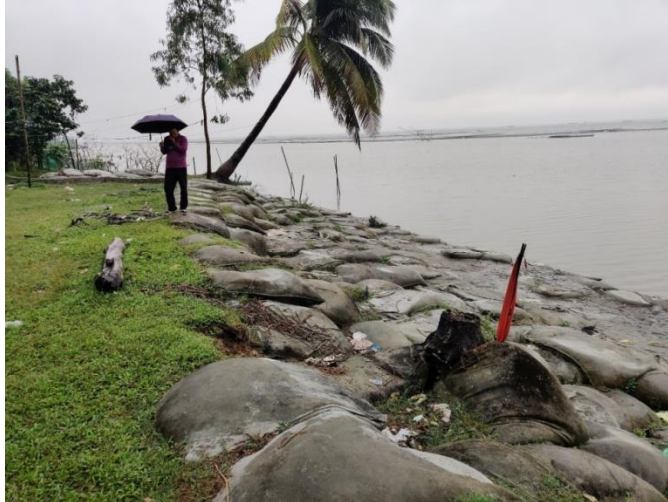
Not too much efforts have been found from the administration to protect the people from the erosion. Only geo bags have been used along the shore but their numbers are also not sufficient. Moreover, lack of regular monitoring has caused the loss of many bags.

Figure 5.10: Geo bags being used to protect Uria Village from erosion

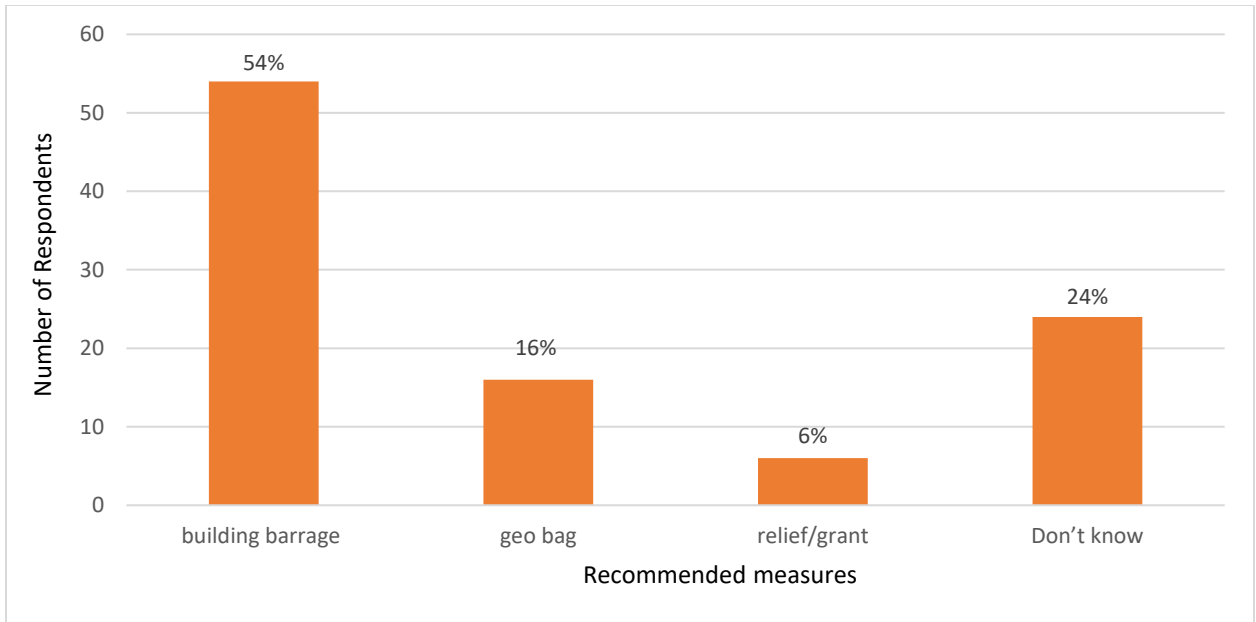
Figure 5.11: Peoples’ perception of techniques to mitigate river bank erosion

From figure 5.11 , it is clearly evident that 54% of the respondents recommended building barrage to protect their locality. On the other hand, 16% people put emphasize of putting geo bags along the shore. However, the only government investment there is putting geo bags. It is a significant finding that people are no more interested in receiving temporary grants or relief as very people think that is it is actually helpful(6%).
