**AN ENQUIRY INTO THE CAUSES OF WATER LOGGING AND THE COPING STRATEGIES  
OF THE URBAN POOR: A CASE OF THE RAILWAY SLUM, KHULNA**

A thesis submitted to the Department of Architecture in partial fulfillment of the  
requirements for the degree of Master in Disaster Management.

Postgraduate Programs in Disaster Management (PPDM)

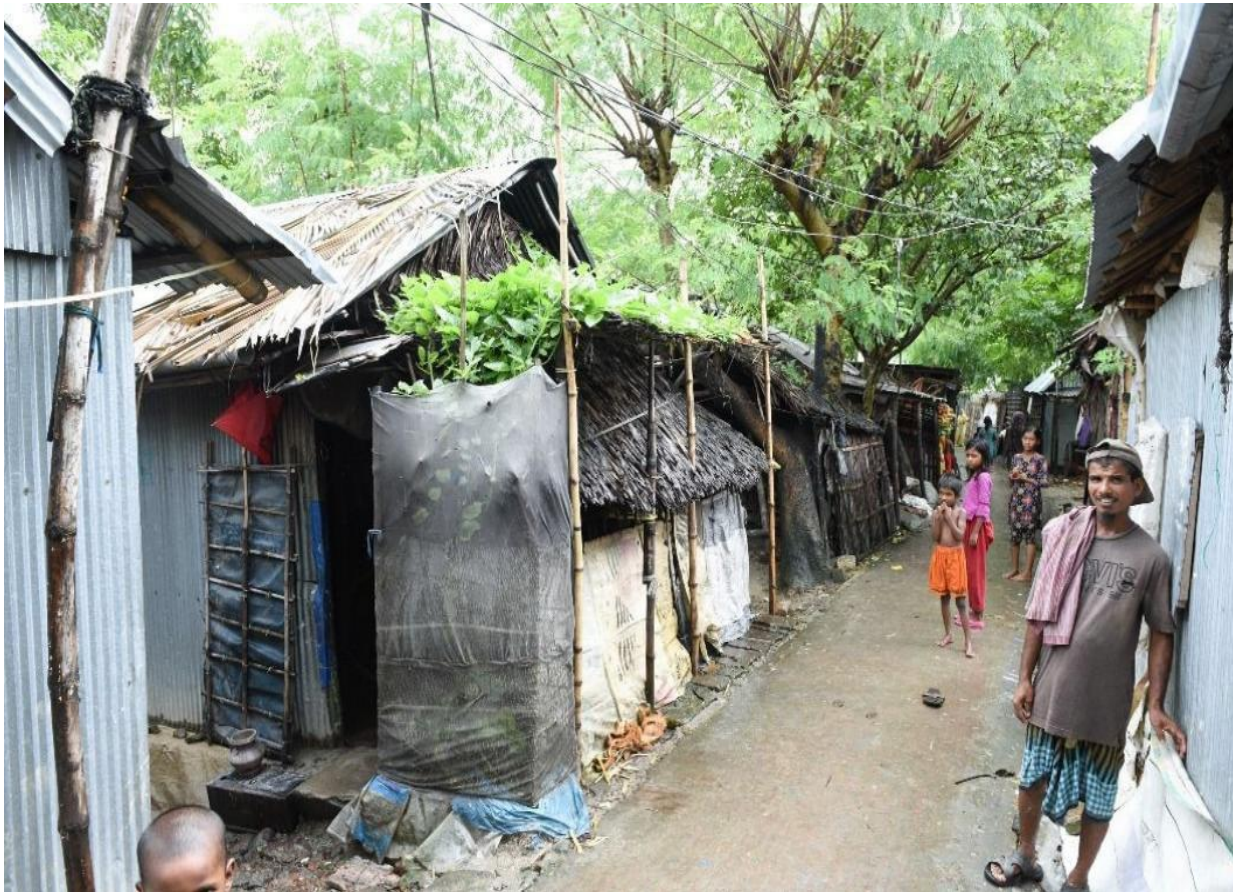
Figure 6: Unplanned housing of railway slum area

The katcha and semi-pacca houses of the slum dwellers were clearly noticeable in the pictures which cover most of the natural drainage. So, this housing pattern is one of the main reasons of waterlogged situation in the slum area. Above all the miserable life of slum dwellers during the water logging period was clearly visible in the pictures, which was taken during the waterlogged condition in monsoon for heavy rainfall. Some pictures are given below:

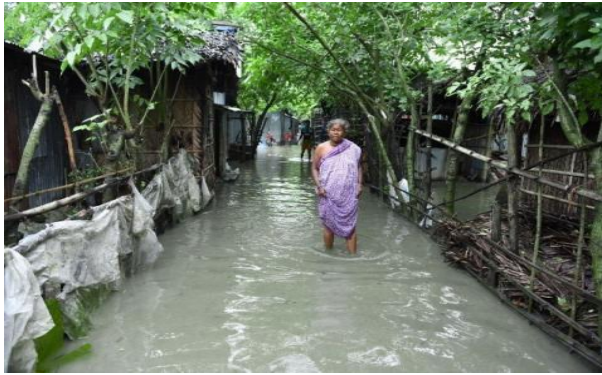
**A:** Condition of roads during waterlogging

From figure 7A, the devastating condition of the roads of the slum during waterlogging condition is observed. During waterlogging condition, the roads of the slum go under knee water which sometimes remains for whole day. At that situation it is quite impossible for the slum dwellers to go outside for their works. The houses of the dwellers are directly connected with the roads. So that the water must be flooded their houses surely which is very painful for them.

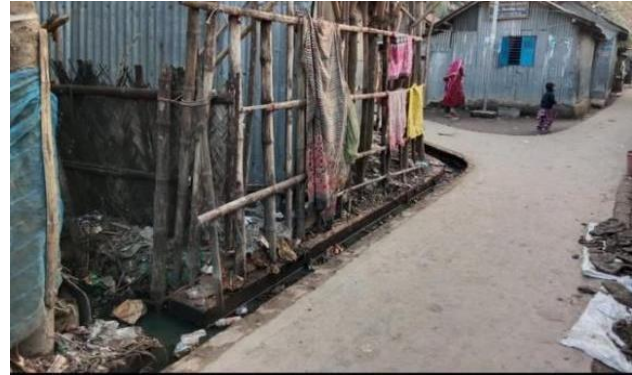
**B:** Poor drainage system of the slum

From figure 7B, the poor drainage system beside the houses of block B of the Railway slum is noticed. The unplanned housing pattern of the slum dwellers covered the natural drainage system. The drains are filled up with garbage and solid wastes which is clearly seen in the picture. Side by side it is clearly noticed from the picture that, the drainage line is too narrow to pass the extreme water flow. Moreover, the picture of figure B also showing the poor condition of the drain lines of block B.

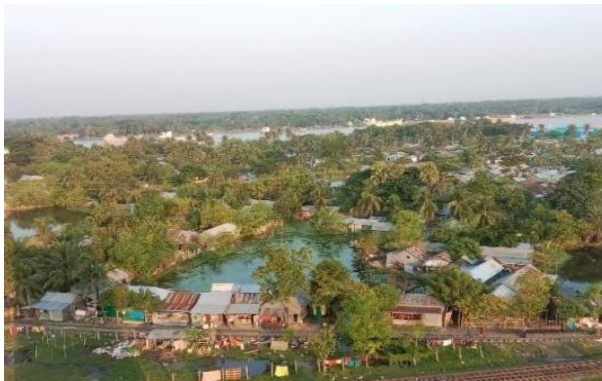
**C:** Full view of the Railway slum

Figure 7C represents the full view of the Railway slum. This picture has been taken during the absence of waterlogged condition. This picture is giving a clear idea of the whole Railway slum. This photograph is taken from a nearby rooftop of the Railway slum. The rail line, infrastructures, roads, green lands, water bodies as well as everything is clearly visible from figure 7C.

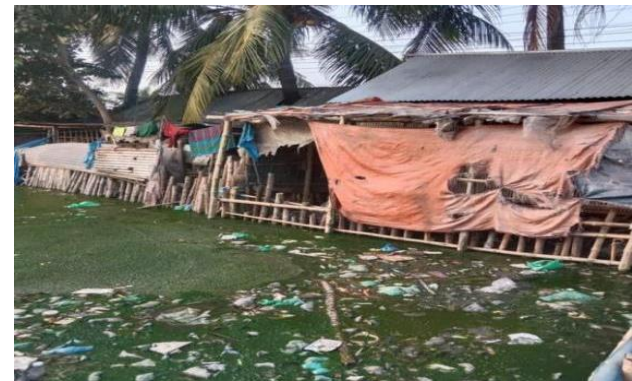
**D:** Unplanned garbage heap

Figure 7D shows the condition of the green lands beside the houses of the slum. In this picture the waste materials are gathered in the field which can go to the nearby drain lines and can create blockage of them. From this picture it is clearly observed that there is a lacking of planned garbage heap in the slum area. As a result, the slum dwellers are throwing waste materials here and there in the slum.

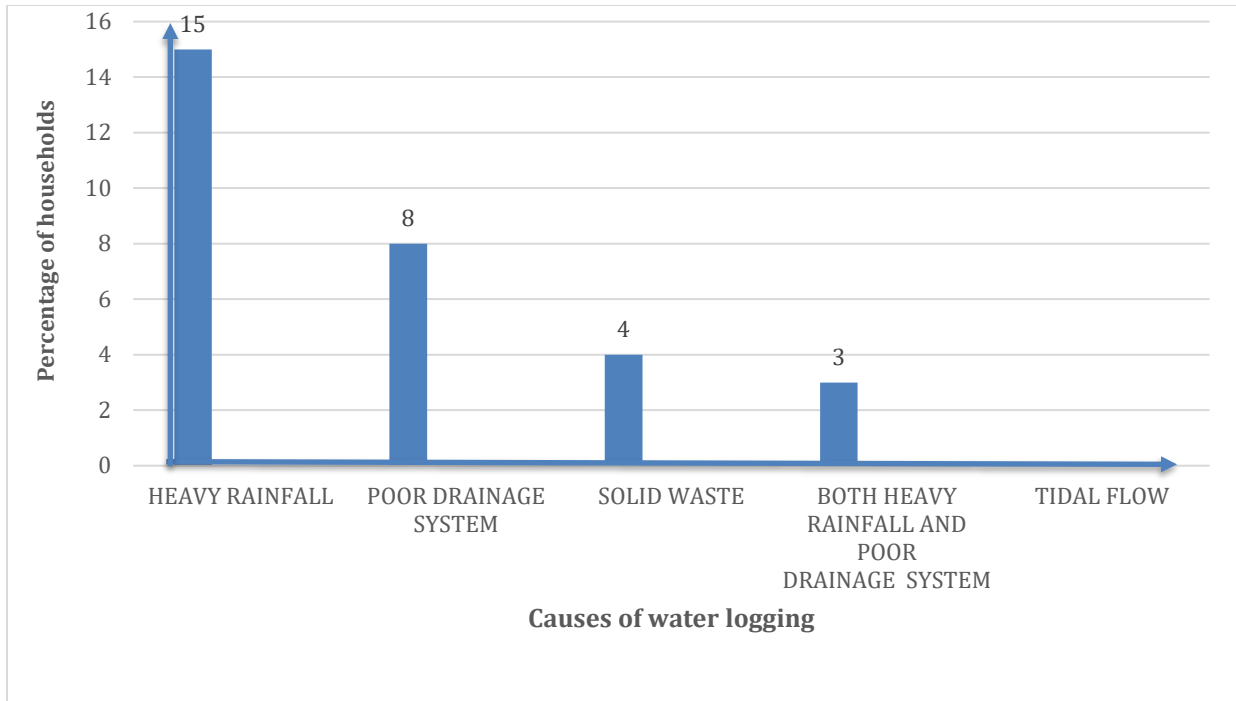
During the survey main reason behind the waterlogging was known from the slum dwellers. Heavy rainfall was cited as the main cause of waterlogging by 15% of slum dwellers, while approximately 8% attributed it to poor drainage systems. Additionally, 4% of slum dwellers identified solid waste and garbage as contributing factors. However, only 3% of dwellers claimed both heavy rainfall and poor drainage system as the main reasons behind waterlogging. No one marked tidal flow as a cause behind the waterlogging situation at the survey time. (Figure 9)

**Figure 9:** Causes of water logging

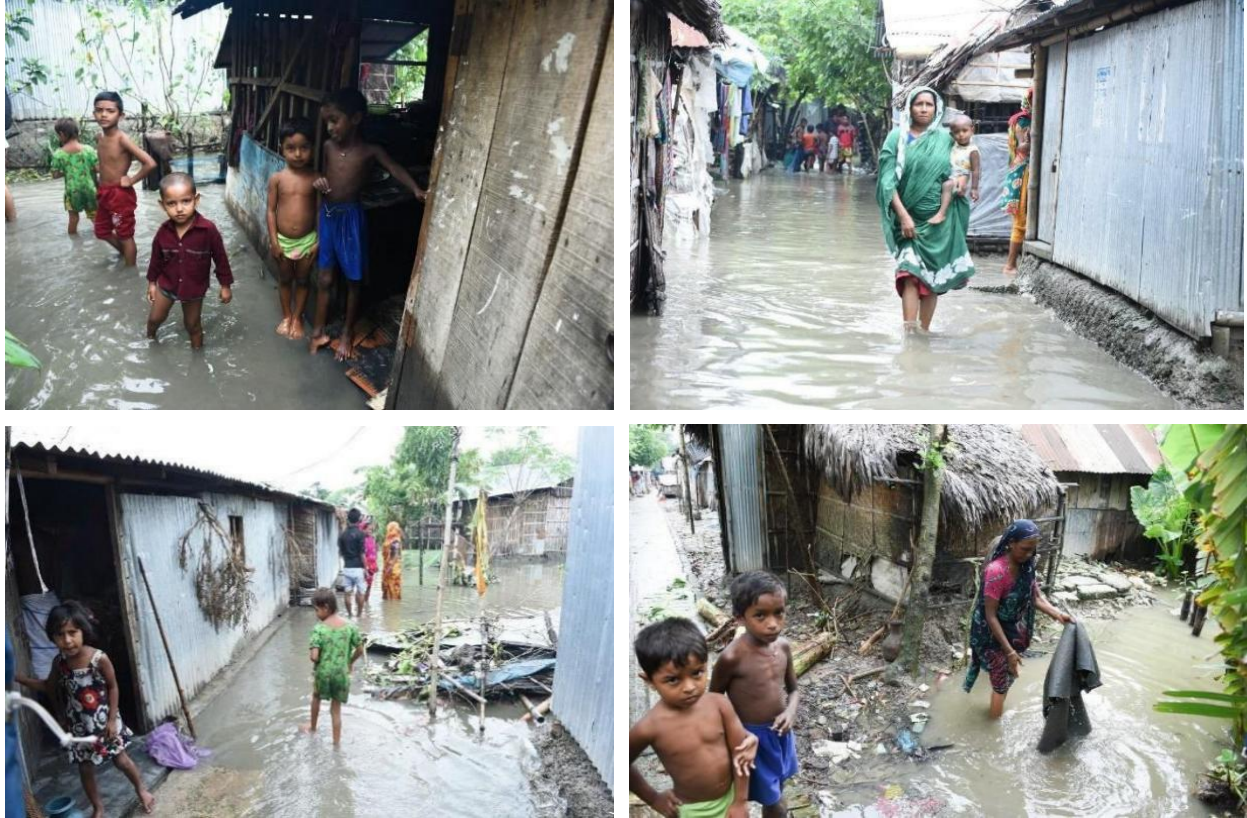
Railway slum area is situated beside the Bhairab River. A canal is connected between the slum area's drainage system & the river which is unfortunately covered by solid waste and that's why it blocks the water flow of the drainage system to the river what creates the waterlogging condition in the slum area. During rainy season, the railway slum area faces the waterlogging condition mostly. Due to heavy rainfall, the waterlogged condition remains for several house even sometimes for a day in the railway slum area. The waterlogging condition hampers the slum dwellers daily life and also damages their houses.

**Figure 18:** Waterlogged zones of block B of railway slum area and miserable life of slum dwellers

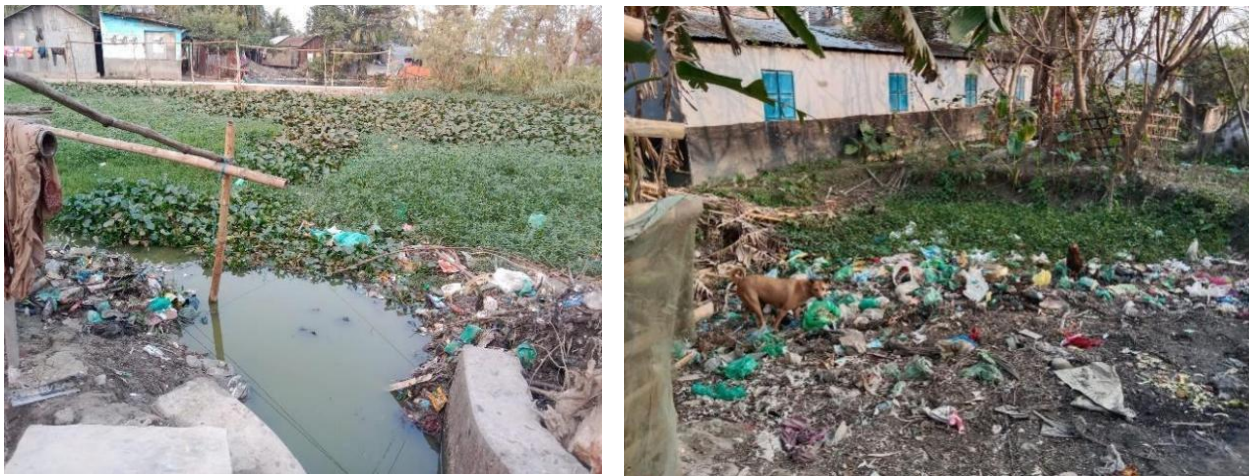
**Figure 19:** Drain blockage and unplanned garbage heap at block B of railway slum area

- As the slum dwellers have built their houses in an unplanned way, it has covered the natural drain lines too. Natural drains are also clogged due to the indiscriminate disposal of solid waste and garbage. In last few years, almost 30% of the natural drainage system areas has been decreased in the railway slum area which is also a major reason behind waterlogging conditions in the slum area.

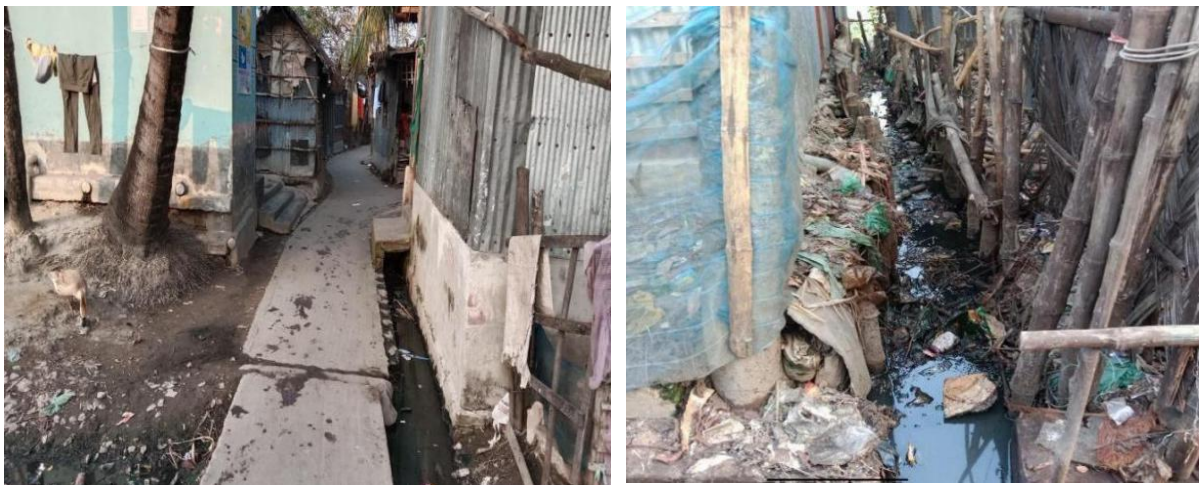
The surveyed area B block is also unconnected with the main drainage network. Though the slum dwellers of block B had made a normal drainage line of 2-meter-long throughout the block later but unfortunately it couldn't be connected with the main drainage line because of unplanned housing and the out passes of the drainage line has been connected with nearby water bodies in B block. This unplanned drainage line is too narrow to pass the extreme flow of water quickly to any water body. So, after any heavy rainfall, the storm water can't pass away quickly by this unplanned drainage line and floods out the B block.

**Figure 20:** Poor Drainage system around the houses of Block B of railway slum area
