**STUDY OF IMPACT ON SURROUNDING LIVELIHOODS
DUE TO RIVERBANK EROSION:
A CASE ON SHIBALAYA'S JAMUNA BANK OF MANIKGANJ**

A Dissertation

**BRAC Institute of Governance and Development (BIGD)
BRAC University, Dhaka, Bangladesh
July, 2015**

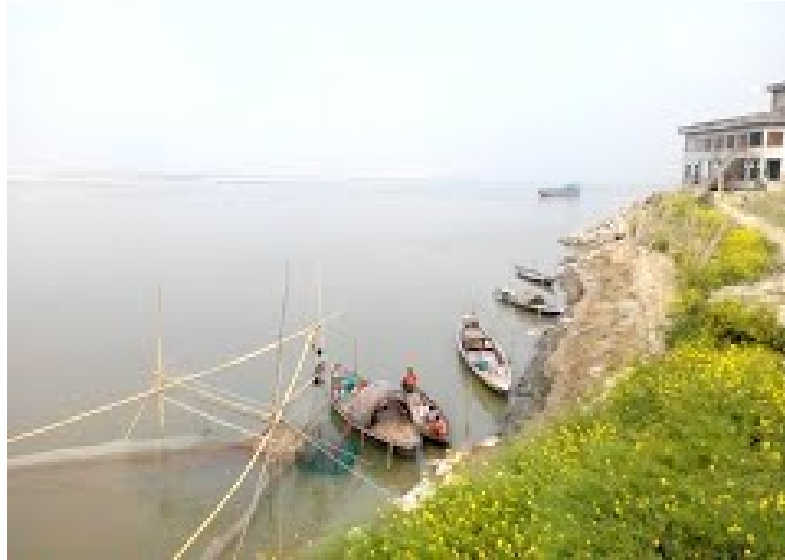
Figure 1.1: Jafarganj Primary School (has gone under water in 2013).

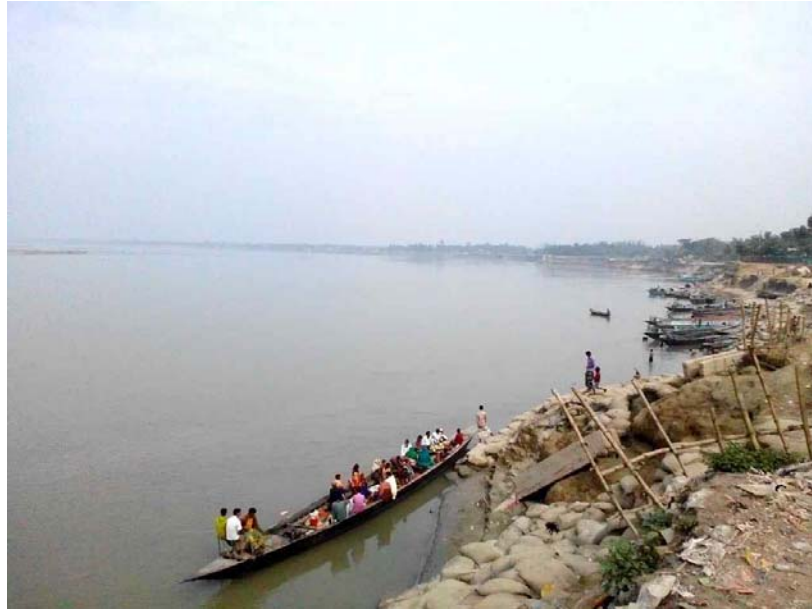
Figure 1.3: Jafarganj Bazar (already eroded due to river erosion).

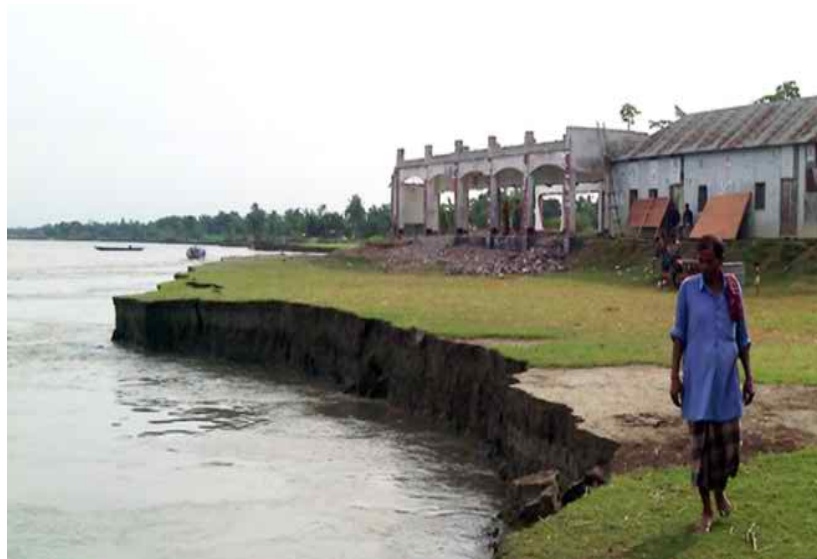
Figure 1.4: Jafarganj High School in Teota union under Shibalaya upazila of Manikganj district is on the verge of collapse into the Jamuna.

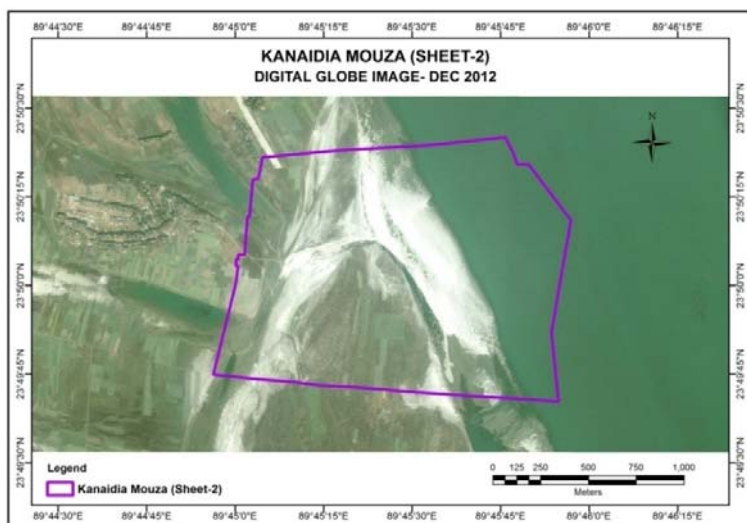
MAP 5.14: Image of Kanaidia Mauza (Sheet-2) in December 2012.

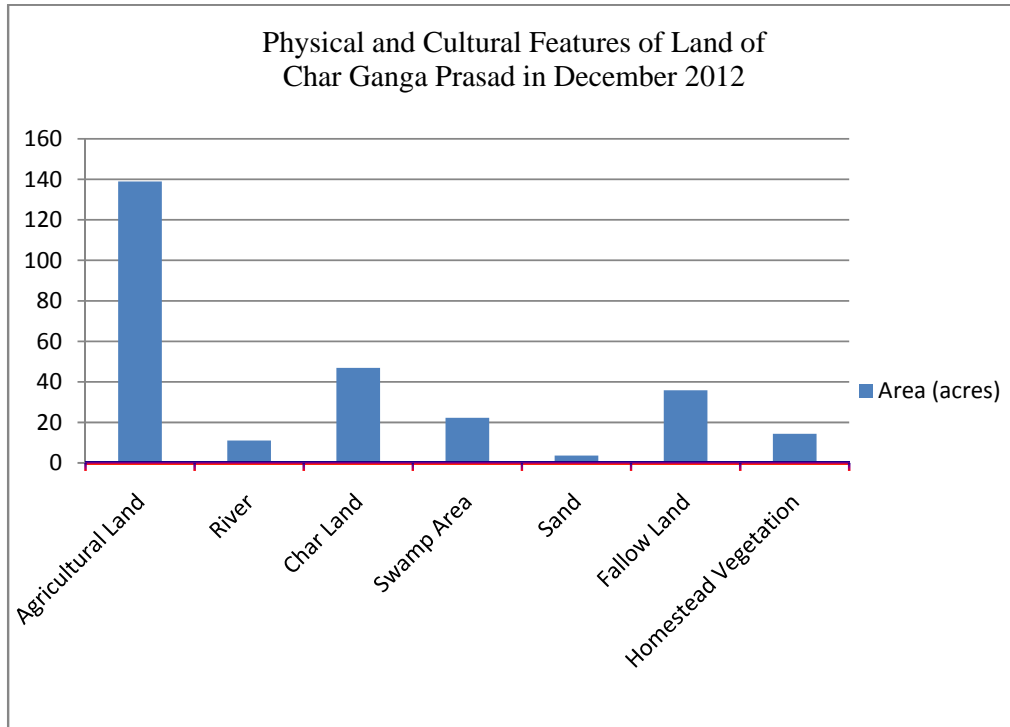
Figure 5.17: Physical and cultural features of lands of Char Ganga Prasad in December 2012.

Again, distribution of Physical and cultural features of lands of Char Ganga Prasad mauza by December 2006, December2012 and July 2015 have been plotted in figure 5.16, 5.17 and 5.18 respectively.

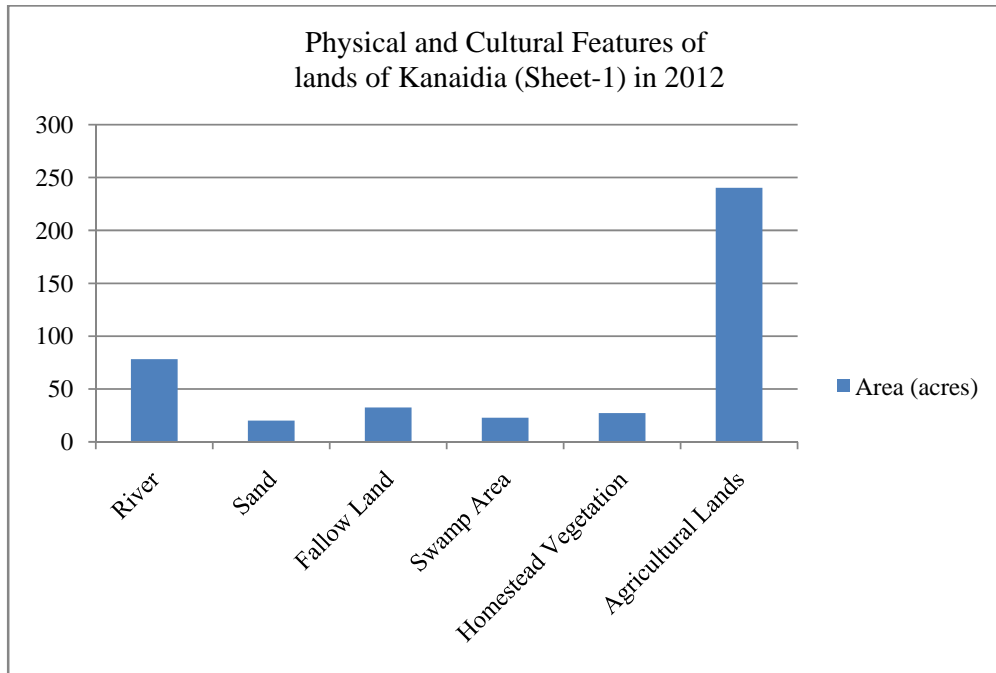
Figure 5.26: Physical and cultural features of lands of Kanaidia (Sheet-1) in December 2012.

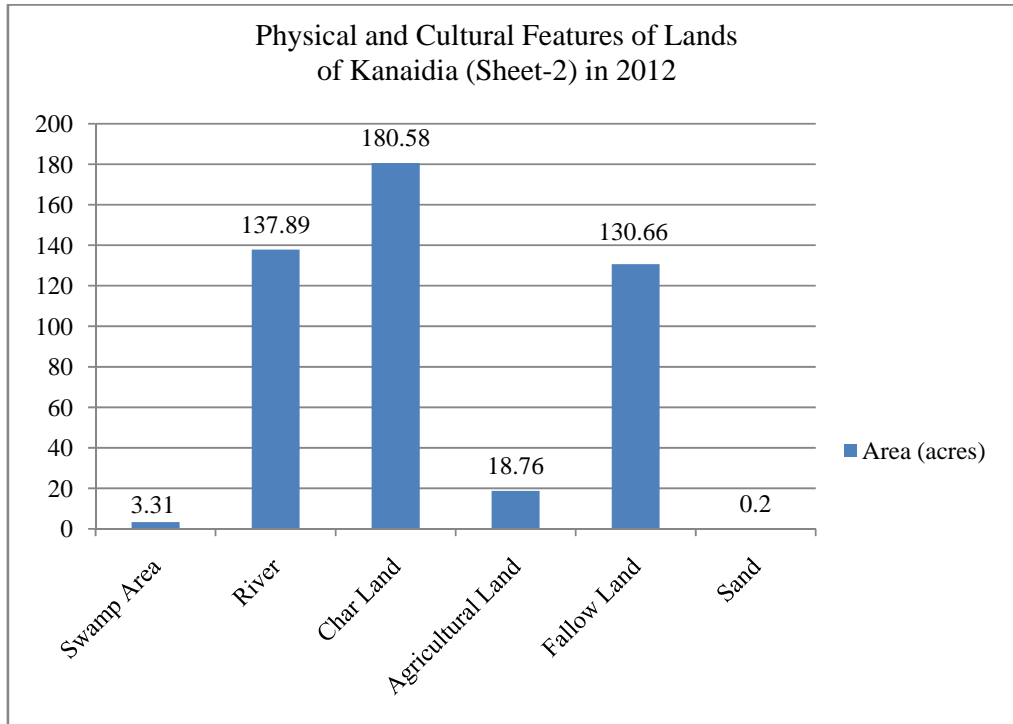
Figure 5.29: Physical and cultural features of lands of Kanaidia (sheet 2) in December 2012
